Navajo Abandoned Uranium Mine

Site Screen Report

Plot 3 AUM Site

Weston Solutions, Inc.

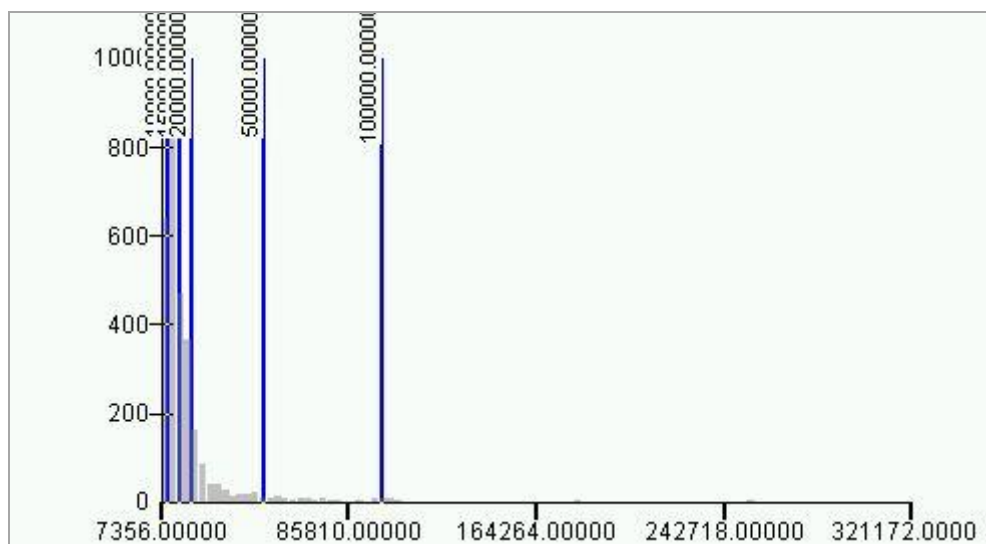
The following chart and statistics were generated by ESRI ArcGIS 9.3.1, and show the general distribution of the site gamma radiation measurements. The horizontal X axis represents the gamma radiation reading levels in cpm (lowest levels to the left). The vertical Y axis represents the frequency of each gamma radiation level.

Count:	3053
Minimum:	7356.00000
Maximum:	321172.00000
Sum:	61017132.00000
Mean:	19985.95873
Median:	13186.00000
Standard Deviation:	26781.74949

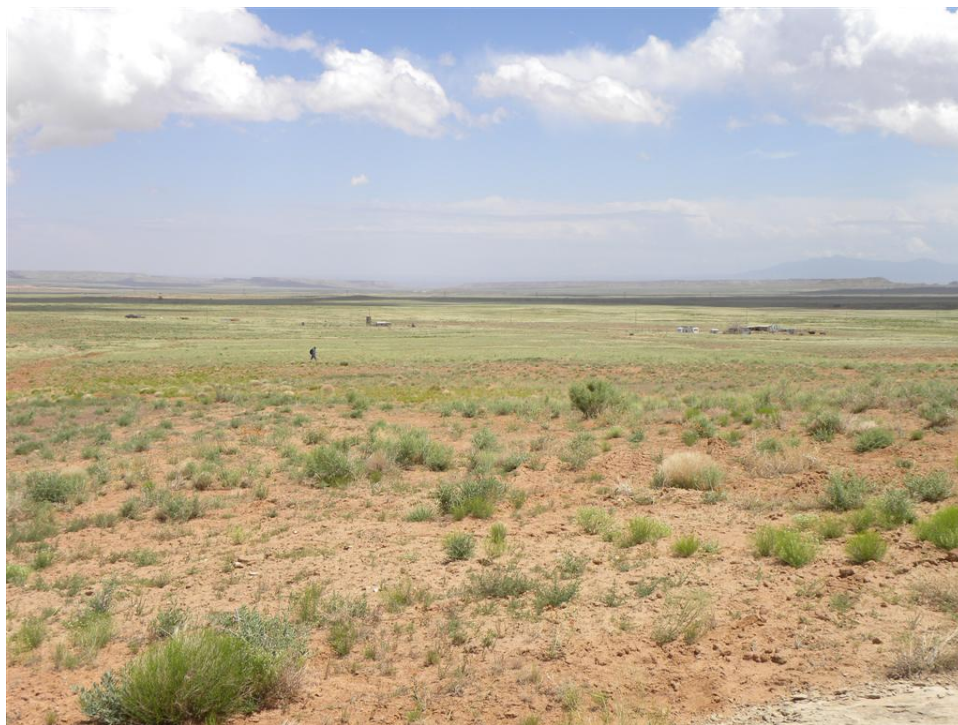
Photo 1. Plot 3 site

Fill material at S boundary continuing down slope along rock edge to the NW; basin & potential burrow area

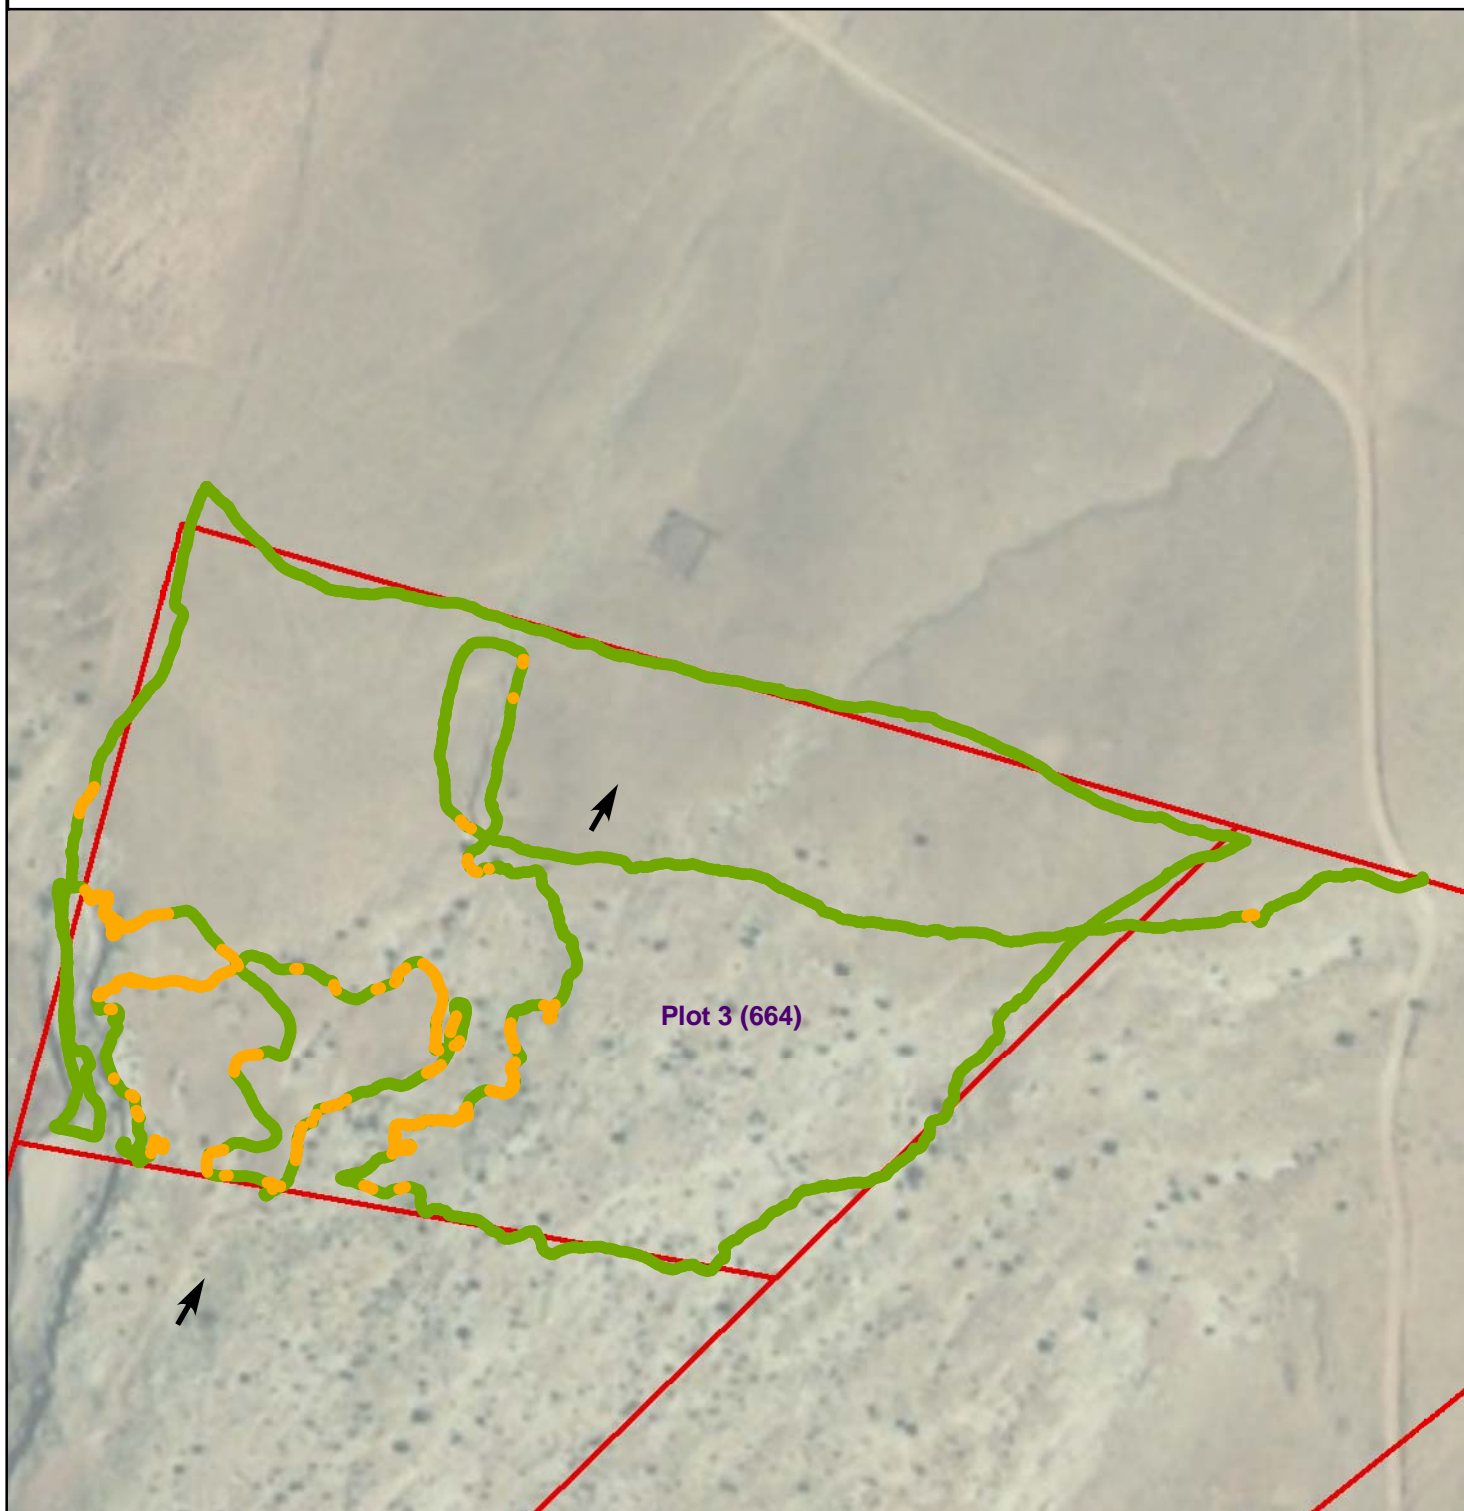
**Figure 1 - Gamma Radiation Measurements, Above Two Times Background
Plot 3 (664)
Teec Nos Pos Chapter, Navajo Nation**

Gamma survey conducted 06/2010
Measured as counts per minute (cpm)

Average background = 9,833 cpm

A total of 3,053 gamma radiation measurements were collected from the mine site, ranging from 7,356 cpm to 321,172 cpm. The measurements are represented in Figures 1 and 2.

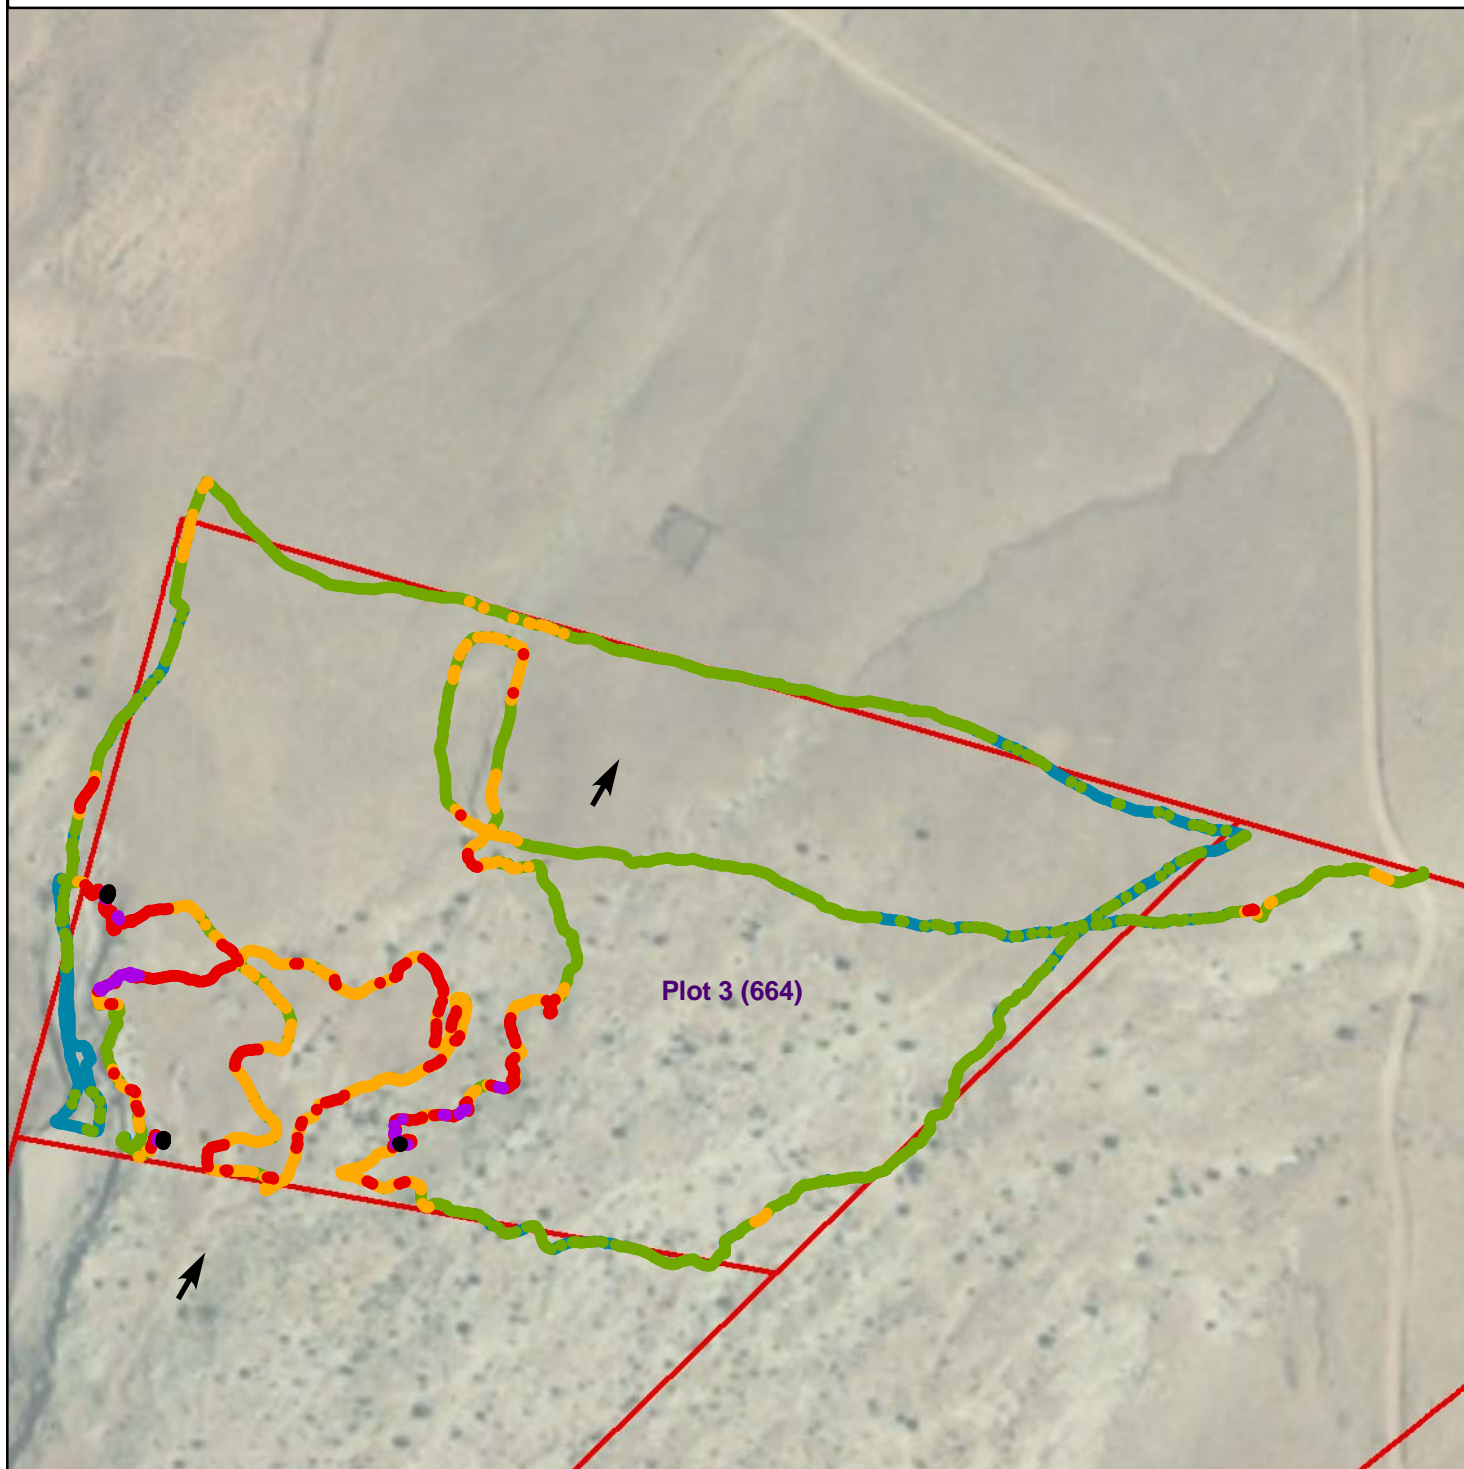
Figure 2 - Gamma Radiation Measurements
Plot 3 (664)
Teec Nos Pos Chapter, Navajo Nation

Gamma survey conducted 06/2010
 Measured as counts per minute (cpm)

Average background 9,833 cpm
